Received: 2026.07.10  
Accepted: 2026.10.01  
Available online: 2026.10.21  
Published: 2026.XX.XXTibial Post Fracture in a Posterior-Stabilized  
Knee Prosthesis: A Case Report and Review  
of the LiteratureAuthors' Contribution:  
Study Design A  
Data Collection B  
Statistical Analysis C  
Data Interpretation D  
Manuscript Preparation E  
Literature Search F  
Funds Collection GACEG **César Abraham Ávila Lozano**  
ABCDEFG **César Alejandro Jiménez-Aroche**

**Financial support:** None declared  
**Conflict of interest:** None declared**Patient:** Male, 92-year-old  
**Final Diagnosis:** Fracture of tibial post

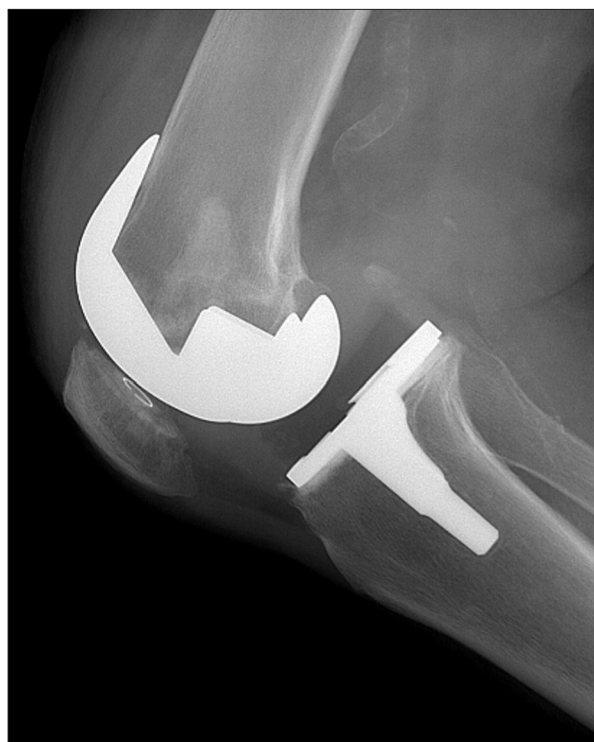
**Figure 1.** Lateral radiograph of the right knee demonstrating the tibial, femoral, and patellar components without evidence of periprosthetic fracture, component migration, or aseptic loosening. The radiolucent polyethylene tibial insert is visualized in position. No gross sagittal component malposition is identified.

Preoperative anteroposterior and lateral radiographs (**Figure 1**) demonstrated satisfactory component positioning without evidence of migration, aseptic loosening, or gross coronal or sagittal malposition. Lateral radiography demonstrated that the tibial component exhibited a near-neutral posterior tibial slope. Because full-length weight-bearing radiographs were unavailable, mechanical coronal alignment and joint-line position could not be quantitatively assessed. Similarly, rotational alignment was not evaluated through dedicated computed tomography; therefore, subtle rotational malalignment could not be definitively excluded. Dynamic fluoroscopic evaluation (**Figure 2, Video 2**) demonstrated anterior translation of the femoral component relative to the tibial insert at approximately 80° of knee flexion, reproducing the patient's mechanical symptoms.

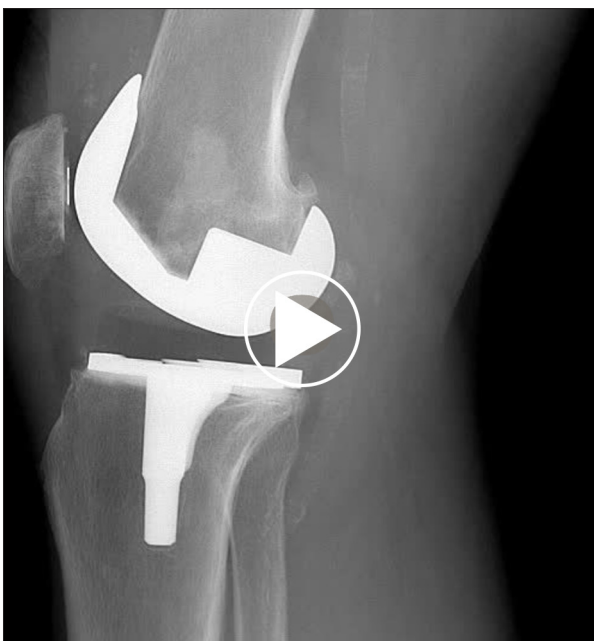
**Video 2.** Dynamic lateral fluoroscopic evaluation of the right knee demonstrating abnormal anterior translation of the femoral component relative to the polyethylene tibial insert at approximately 80° of knee flexion, reproducing the patient's mechanical symptoms.

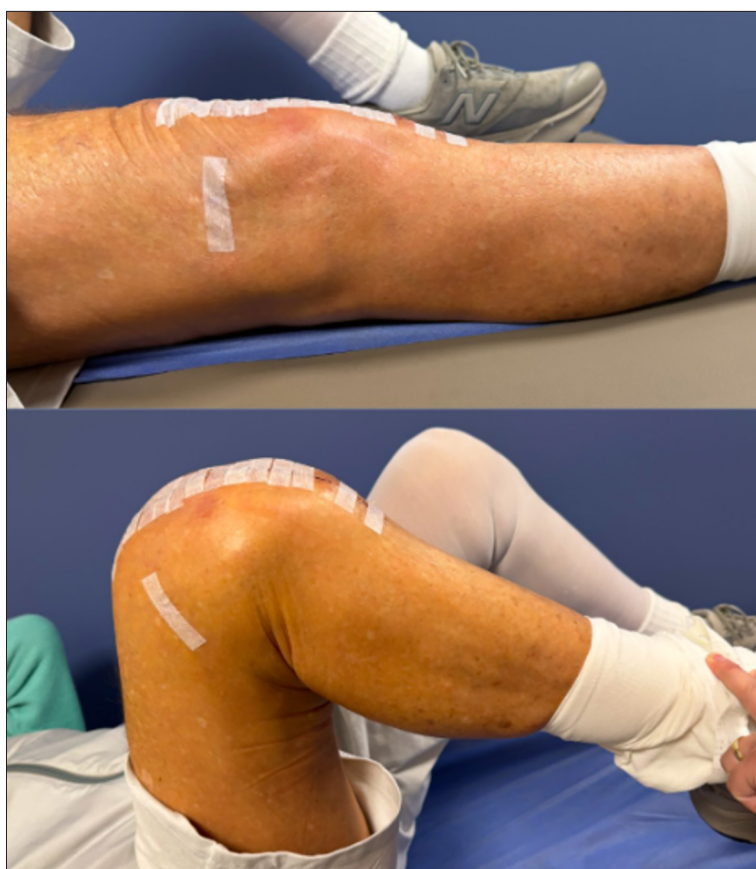
**Figure 5.** Clinical photographs obtained at postoperative follow-up demonstrating full knee extension and approximately 100° to 110° of flexion, with restoration of a functional range of motion.
